Diagnosis report of 2017 VOLKSWAGEN PASSAT B8 Comfort

Summary of diagnosed issues

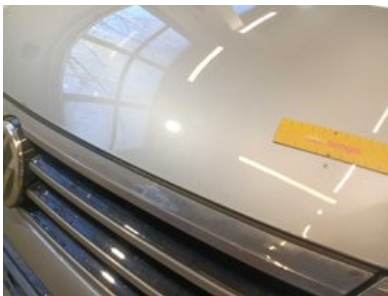
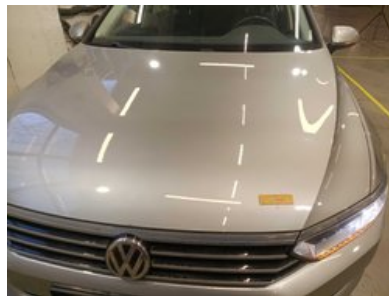
- ✔ **1. Front:** Hood - Visual Damage

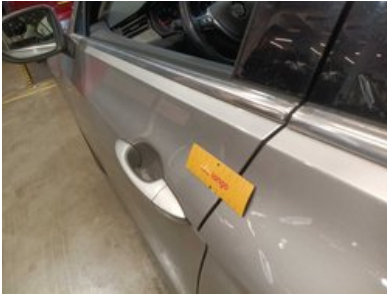
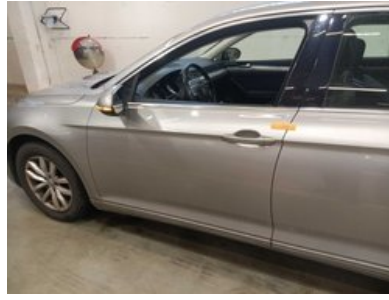
✔ **2. Side:** Left and Right Side - Visual Damage and Scratches

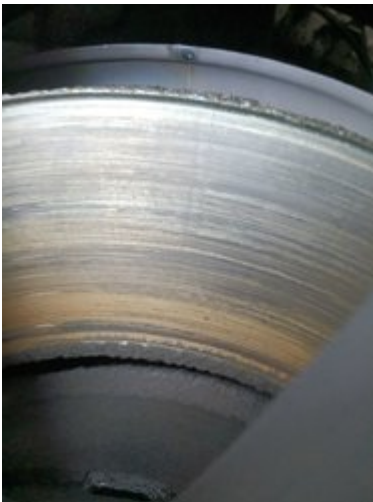
✔ **2. OTHER:** Front Brake Discs Including Pads

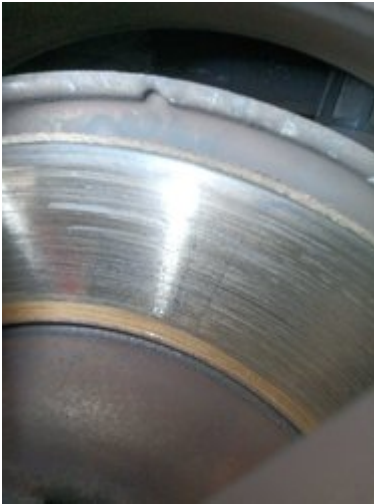
✓ **3. OTHER: Rear Brake Disc and Pads**
