# Diagnosis report of 2018 TOYOTA COROLLA Active

# Preparation and repair report of 2018 TOYOTA COROLLA Active

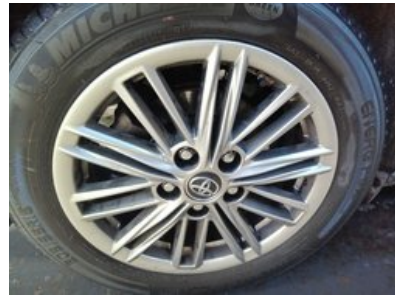
### ✓ 1. Side: Wheels - Condition

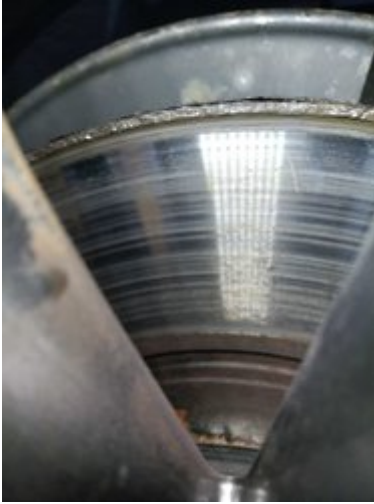
✓ **3. BRAKES:** Front Brake Discs Both

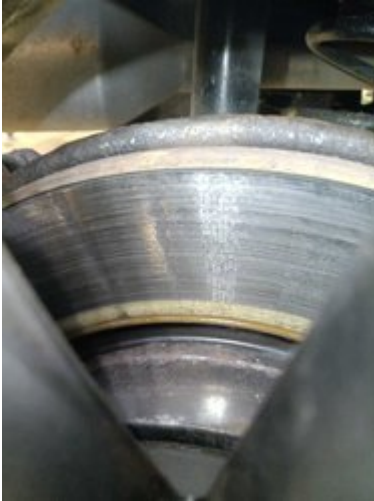
✓ **4. BRAKES:** Rear Brake Disc (Both)
