Diagnosis report of 2021 PEUGEOT 2008 GT Pack

Diagnosis details

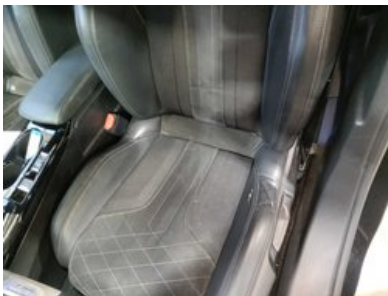
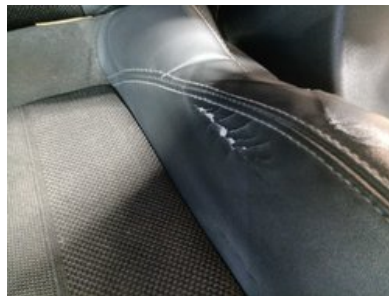
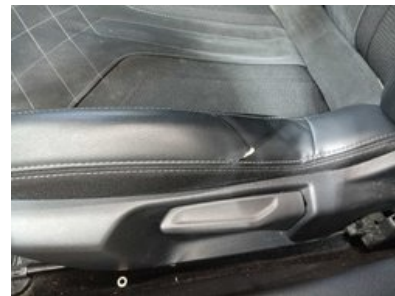
- ✔ **1. Seats:** All Seats - Condition

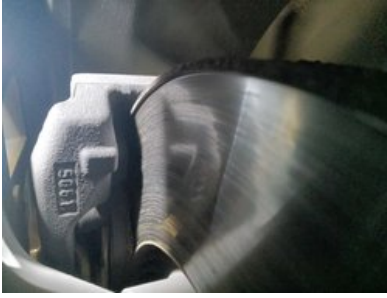
✔ **2. OTHER:** Front Brake Discs Including Pads

- ✓ 1. Engine Oil and Filter
- ✓ 2. Change Tires
- ✓ 3. Front Brake Discs Including Pads

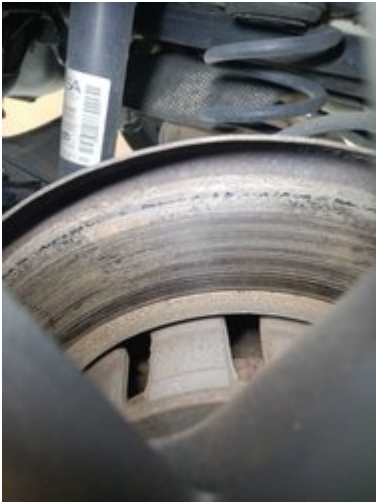
✔ **4. OTHER:** Rear Brake Discs Including Pads

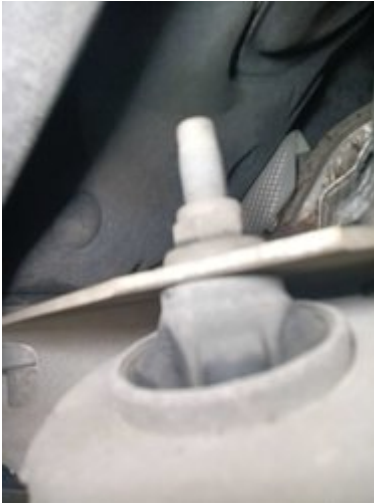
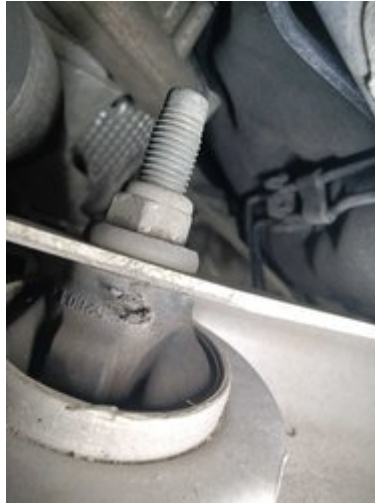
✔ 5. OTHER: Suspension Lower Arm
