Diagnosis report of 2020 PEUGEOT 208 Active

Preparation and repair report of 2020 PEUGEOT 208 Active

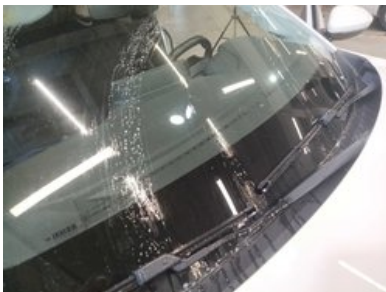
- ✔ **1. Front:** Window Wiper Rubber and Handle (Front and Rear) - Condition

- ✓ 1. Engine Oil & Filter Change
- ✓ 2. Camshaft Drive Belt
- ✓ 3. Change Front Wiper (Mechanical)
- ✓ 4. Charge Battery

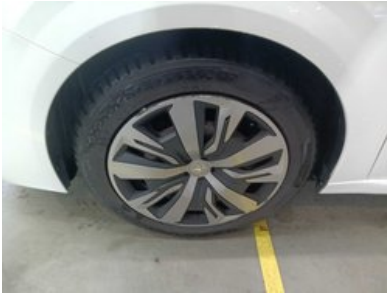
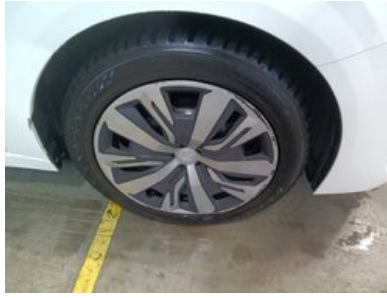
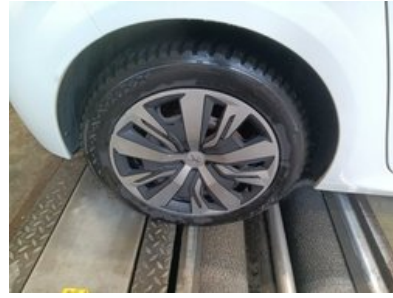
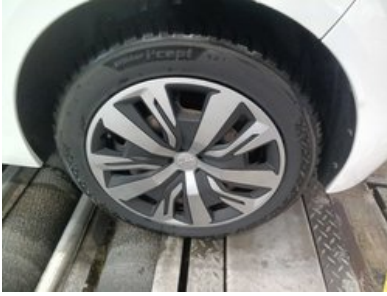
✓ 1. Side: Wheels - Condition

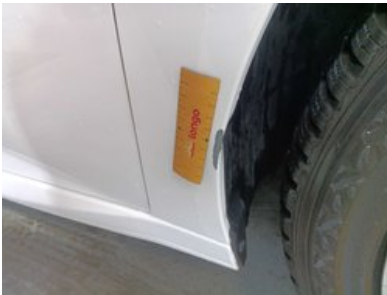
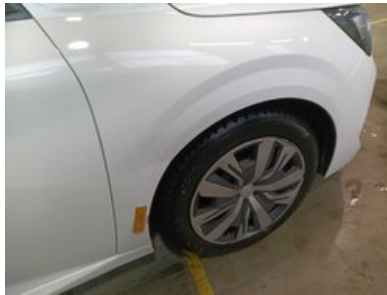
✓ 2. Side: Left and Right Side - Visual Damage and Scratches

- ✓ 1. Paint Front Fender

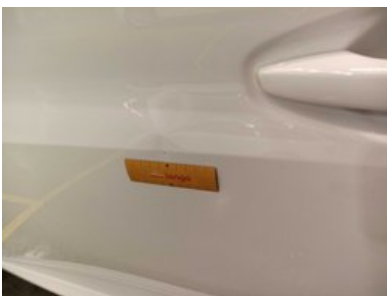
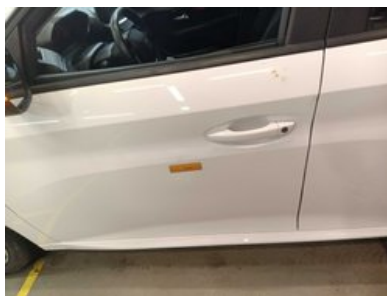
✓ 3. Side: Left and Right Side - Visual Damage and Scratches

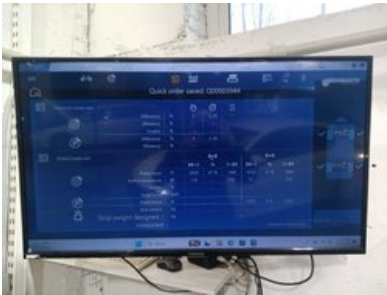
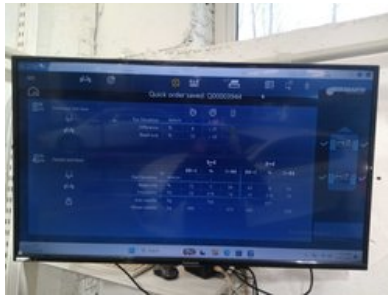
✓ 2. Brake Test Line Results

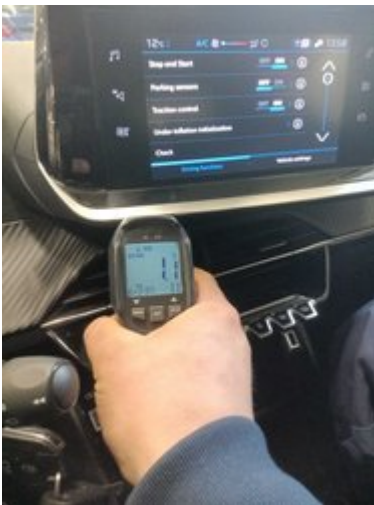
✓ 3. Air-Conditioning Measurement
