# Diagnosis report of 2018 TOYOTA COROLLA Active

## Summary of diagnosed issues

During the comprehensive diagnosis conducted by Longo, 7 issues were identified in the vehicle.

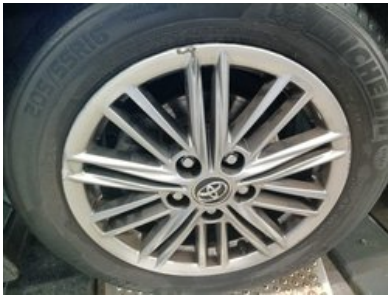
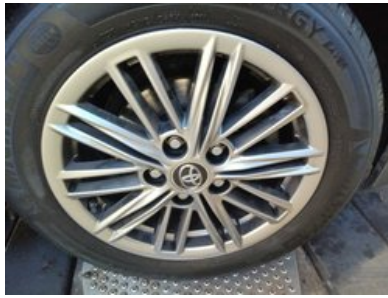
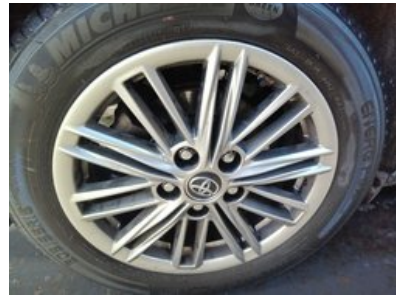
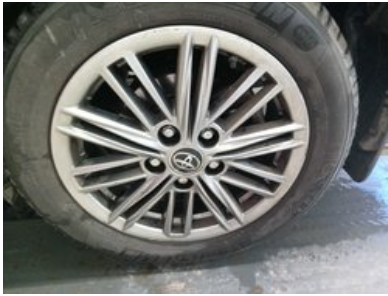
### ✓ 1. Side: Wheels - Condition

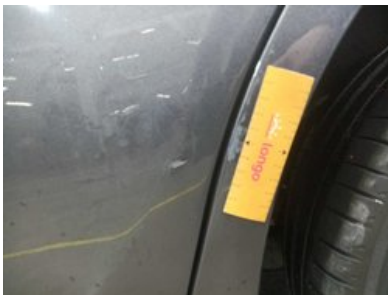
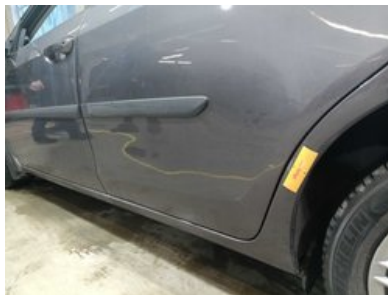
### ✓ 2. Side: Left and Right Side - Visual Damage and Scratches

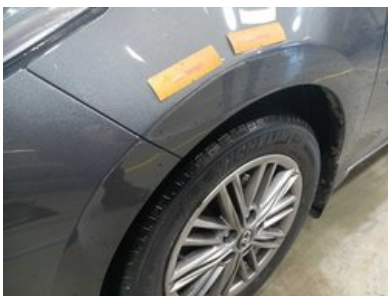
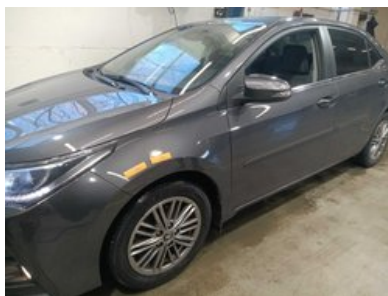
### ✓ 3. Other: Additional Polishing Tasks

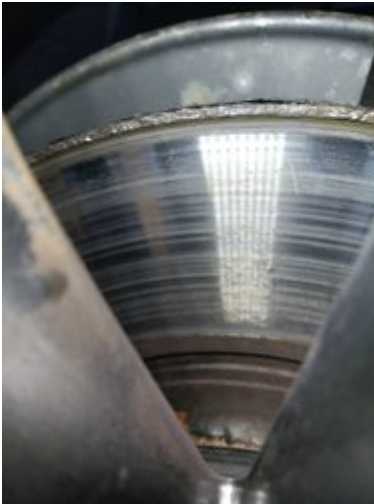
✓ **3. BRAKES:** Front Brake Discs Both

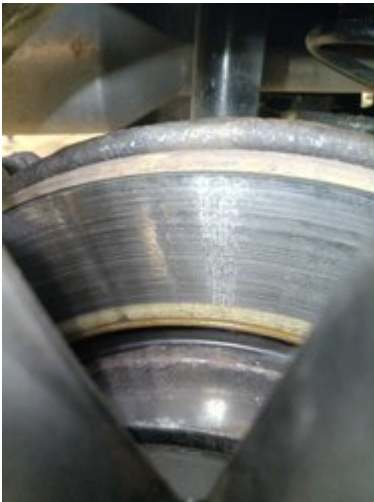
✓ **4. BRAKES:** Rear Brake Disc (Both)
