Diagnosis report of

2015 NISSAN JUKE Acenta

Diagnosis details

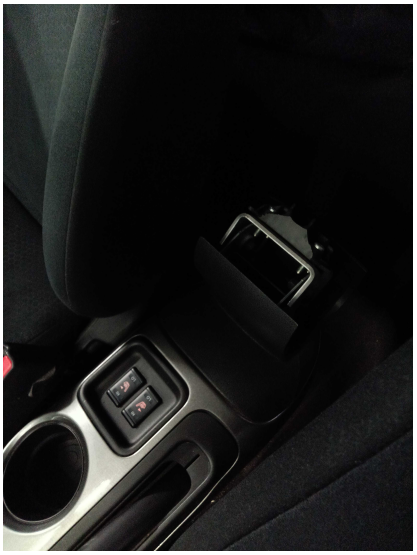
1. INSIDE: Armrest - operation and condition

- Change armrest

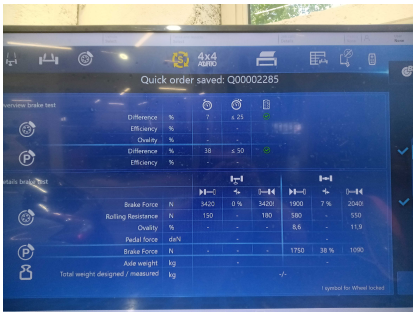
1. OTHER: Brake test line results

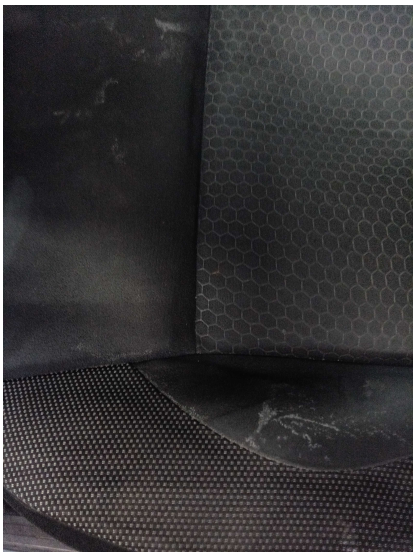
2. SEATS: All seats - condition
